## PTO Driveline Installations

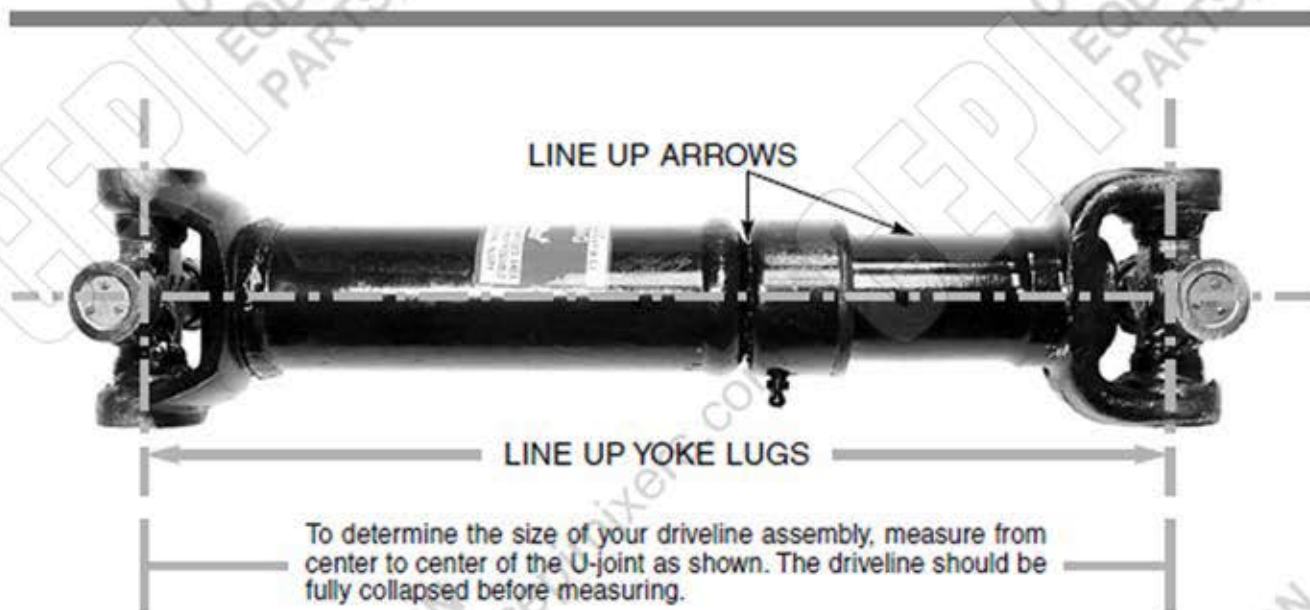
Correct driveshaft angle and proper phasing of the U-joints are important in maintaining long life and quiet running shafts. In phase, the slip yoke lugs/ears and the tube yoke lugs/ears are in line. The driveline should have an alignment arrow stamped on the yoke and the tube shaft to assure correct phasing when assembling the components. If your driveline has no alignment marks, they should be added before you disassemble the shaft to assure proper reassembly.

The shafts of the driving and driven units should be parallel; the yokes of the drive shaft assembly should be in line, in the same plane. A list of U-joint problems that will cause failure include one or more of the following:
